# STS-107 Columbia Reconstruction Report

**NSTS-60501**

JUNE 30, 2003

Stephen J. Altemus,  
Columbia Reconstruction Director, NASA

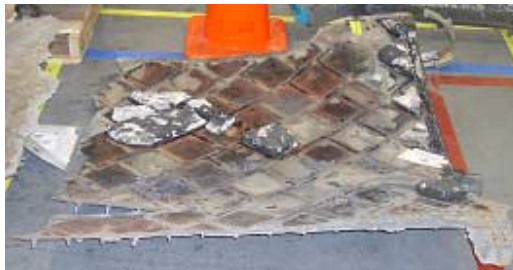
Item 35834

These items included the right hand and left hand ET door, two large skin pieces (35834, 76544) on each side of the vehicle centerline, and a portion of the lower Xo1307 bulkhead. The recovered pieces of structure on the left hand side have more heat related effects than those on the right hand side, except for the internal thrust structure items of high ballistic coefficient. Numerous tiles were identified as possible aft tiles; however, their final location was not determined due established priorities. The only tiles that were assessed were on the largest of the recovered pieces. The exposed filler bar/remnants were more charred on the left hand recovered pieces than the right hand.

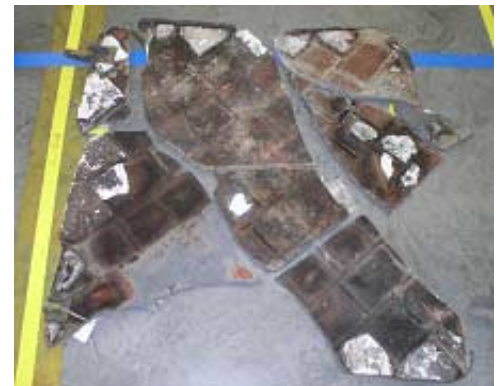
LH ET Door

The right hand ET door (53830) is fully intact with fracture edges at each of the two hinge points. Approximately sixty percent of the tile is still bonded. The OML surface and the primer on the IML of the door is not discolored. In comparison, seventy-five percent of the left hand ET door was recovered, in seven pieces, and has only five percent of the tile fragments attached. Two large floor skin pieces recovered accounted for nearly the entire area between the left hand and right hand ET doors. The right hand piece (76544)

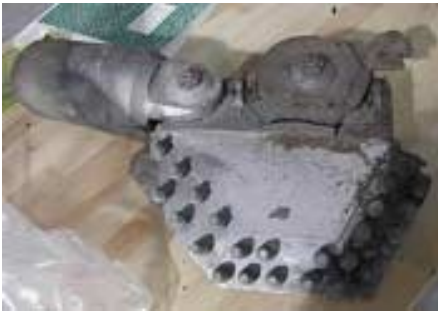
Item 1181

Four additional recovered pieces of primary structure each having heavy thermal erosion and melting on the edges are a thrust structure strut, beam, and strut attach points (36055, 42928, 1181, 24846).

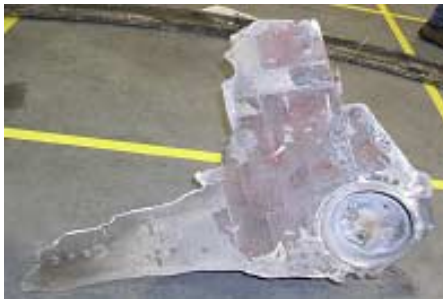
Item 49366

The RH sidewall hoist point (49366) includes a portion of the mid-to-aft fuselage and attach fittings. This piece has heavy thermal erosion from the aft side evidenced by missing and melted collars

on the exposed fasteners.

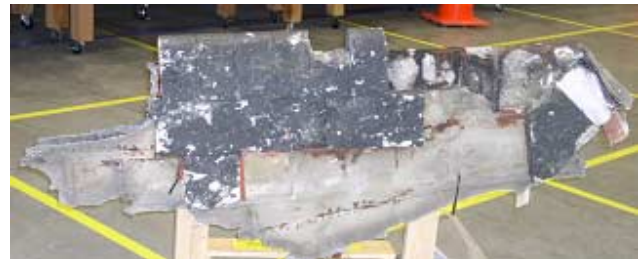
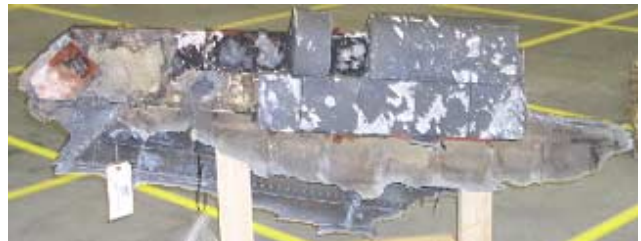
*Item 52092*

Two leading edge items have sections of left hand and right hand outer skin, the tip cap (1633) and the leading edge forward cover (52092). The forward cover has a prominent flow pattern in the upward direction at an approximately 60 degrees from the leading edge spar plane. Items lower on the vertical stabilizer show more signs of heat damage than items that are higher and aft.

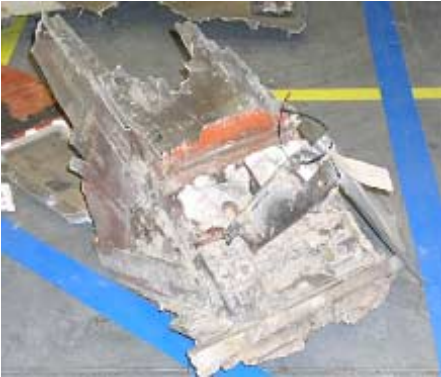
*Item 2199*

primary structural attach points between the vertical fin and the fuselage were recovered, the forward attach fitting (2199) and the right hand rear attach lugs with shear ties. The fractures occurred in the surrounding tail and fuselage structure and not with the primary attach bolts.

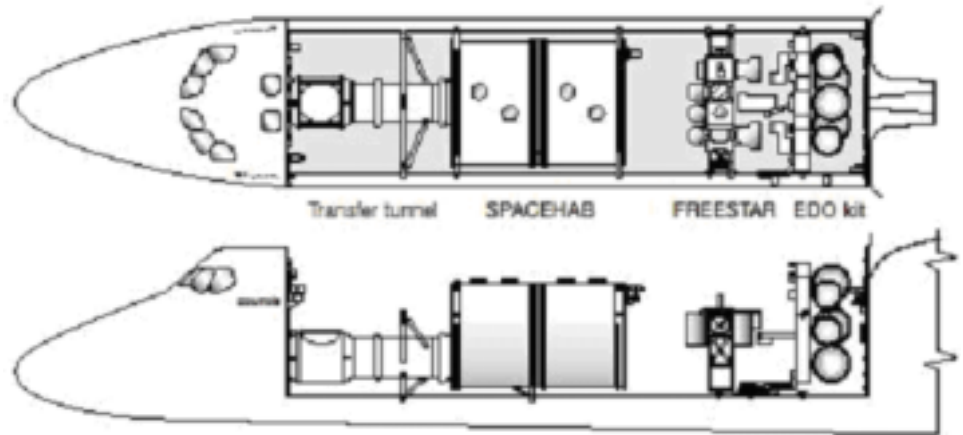
Several items have been identified from the tunnel assembly. The 7.87-inch forward tunnel section was identified nearly intact with the forward trunnion strut attach points and two partial struts attached. The ring for the forward flex section is attached but the rubber portion is burned adjacent to the ring and the opposite ring is missing. The portion of the tunnel that connected to the aft of this section appears to be melted and has

fracture surfaces. The rear strut attach ring of the tunnel was recovered with two partial strut sections attached. The upper strut attach bracket is torn from this flange leaving an incomplete ring. Another flex section ring with a partial thermally

degraded assembly was recovered but not positively identified as the remnants of the forward or aft flex section. One complete adjustable strut and several partial sections of struts have been recovered, as well as four trunnion assemblies and the keel assembly, each with partial struts attached. All of the tunnel assembly items recovered appear to have been exposed to extreme temperatures and heating effects.

*(Note: the above picture is missing tunnel forward trunnions)*

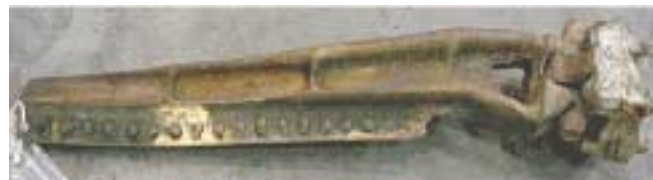
Item 1678

Both the port and starboard side fittings were recovered with evidence of high heating. Each fitting exhibited failures at both its crew module interface and Xo582 frame interface. The crew module interface failed at the longeron tab on both the port and starboard sides. On the Xo582 frame interface, the starboard side (1765) experienced a lug tensile failure while the port side (1678) fittings pulled through the Xo582 frame.

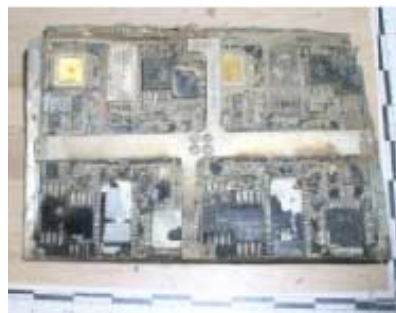
*Item 44309*

Most of the circuit cards (44309) were damaged from exposure to excessive heat. This damage was evident by missing solder traces, loose components normally held in by solder, missing components. In the most extreme cases the boards appeared to have been heated so much that the resin holding the fibers together, have burned away leaving charred, frayed material. Many of the circuit cards were also broken and only pieces remained.

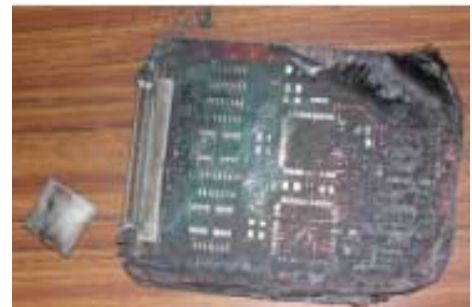
*Item 15132*

The LRUs in the aft avionics bays appear to have suffered from more heat and damage than those in the forward. No LRUs were recovered intact, and the cards from the advanced master event controllers (AMECs) (15132), aero-surface amplifiers (ASAs), ascent thrust vector control (ATVC) controllers, and cryogenic controllers were badly damaged. Identifiable LRUs were recovered, but in all cases they were missing their external skins and were identified by internal components.

The recovered LRU cases were heated to temperatures high enough to cause the aluminum to melt. Most part number, serial number, decals and other identifying markings on circuit cards were damaged or destroyed by exposure to high heat.

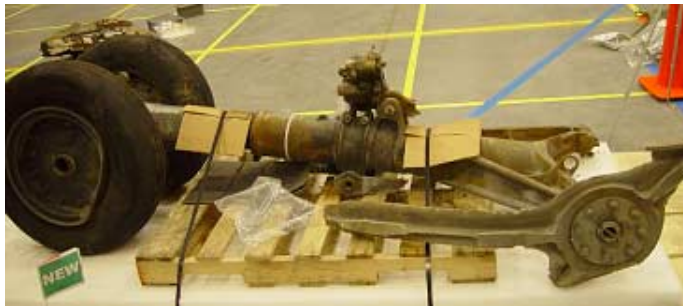
Item 9226

(9226) is intact to the point that hydraulic fluid was present and GN2 was almost at flight pressure after recovery. The nose wheel steering actuator has some heat damage. The left hand (aluminum) trunnion is still attached to the gear and the visible support ribs have high temperature web fractures. Both deflated tires are intact and attached to the wheels, which remain on the axle. The left hand wheel is intact and the right hand wheel is mostly intact, however, the inboard bead had broken free. Half of the fracture bead was recovered. The retract link tang is attached to the strut with about three inches of the link remaining.

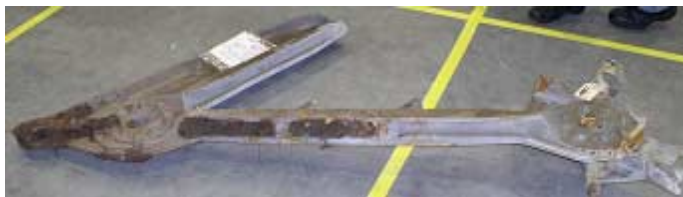
Item 565

The three remaining trunnions (565 and 2187) were recovered as two debris pieces. The main ribs between the trunnions are mostly intact and the webbing on the ribs shows a combination of heat effects and overload failures. Half of the door uplock cam assembly (1803) was recovered as well as several hinges

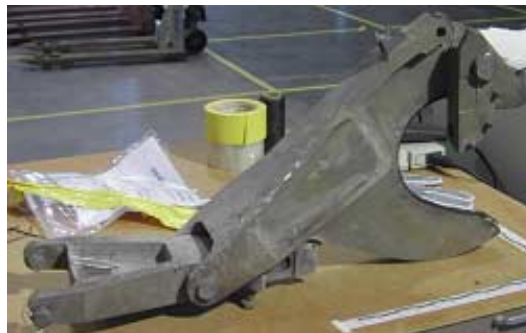
Item 1803

for the doors. Only minimal evidence of thermal exposure is present. A large portion of the upper and lower drag brace assembly (2540 and 2218) was recovered. Both parts have broomstrawing and overload failures.

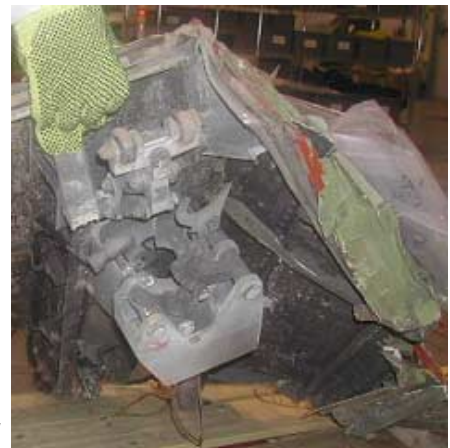
Item 561

Several pieces of the wheel well box structure were recovered and only superficial heat discoloration of the koropon is present. Parts of the uplock assembly were attached to these box parts and predominantly show evidence of overload failure. An example is item 561.

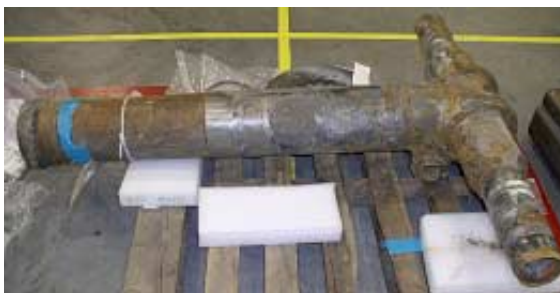
*Item 1257*

With the exception of the upper cylinder and the lower piston, only a small percentage of the left hand MLG was recovered. Most of the hardware shows signs of high temperature exposure. The lower piston assembly (1257) exhibited melting and thermal damage on the lower end. The outboard axle threads are gone with melted surfaces where they begin on the axle. There are burn through areas just aft of the jack pad and at the lower scissors mount. Both ends of the scissors mounting pin are melted. More than 95% of the bronze/aluminum portion of the upper end of the piston is missing. Sawtooth fractures and melting are visible. The piston barrel is in relatively good condition. The forward side of the piston barrel has much less chrome damage and less evidence of melting (bronze/aluminum material) than the aft side.

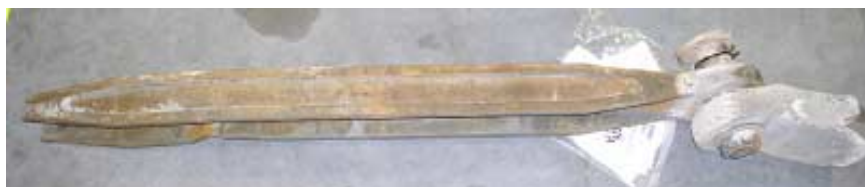
*Item 24823*

The lower drag/lock brace (24823) has minimal thermal damage. The upper pin and outboard mating clevis are still attached. The attached clevis piece, and the adjacent clevis piece (81992) recovered separately, are both thermally damaged. These two are the only aluminum parts recovered for the left hand MLG that is not protected by other hardware during flight. The lower end of the brace demonstrates a typical over-stress condition.

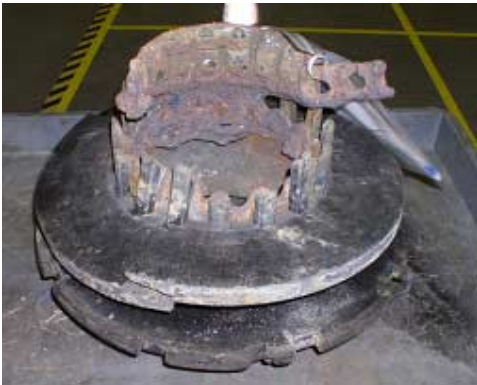
Item 1805

conditions ranging from intact to fractured small pieces. The left hand outboard brake body (1805) was recovered and has extensive thermal damage.

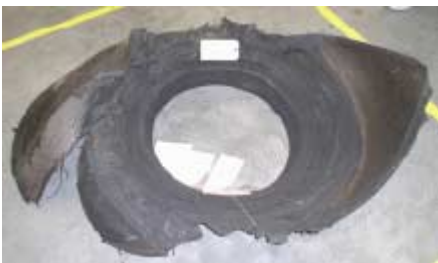
Item 197

The tires were recovered separated from any other structure. The left hand outboard tire (197 and 210) is split into two pieces around the circumference and directed heat is evident on the inboard side of the tire. The inboard tire (2168 most probable location) is in good condition with only minor thermal damage to the entire outer surface and a split in the body.

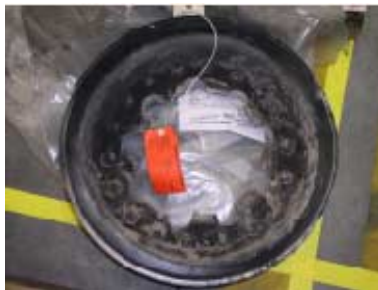
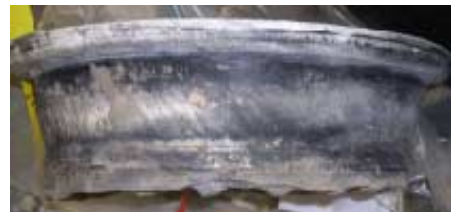
Item 567

The right hand outboard wheel (567) has a melted fracture surface on the inboard side of the wheel and the center portion of the wheel is missing.

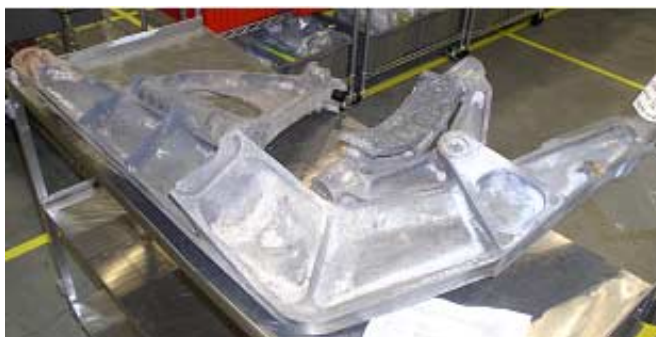
Item 84265

The MLG door retract actuator beam (84265) has some thermal damage as well, however, it is also mostly intact.

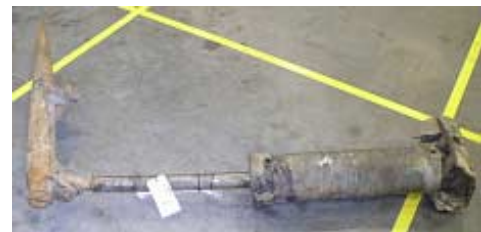
Item 27323

The gear retract actuator (27323) is intact and is attached to the upper portion of the landing gear. The gear portion has evidence of high temperature exposure. The down lock brace clevis fitting (45724) that attaches to the upper cylinder was

also recovered with similar thermal damage.

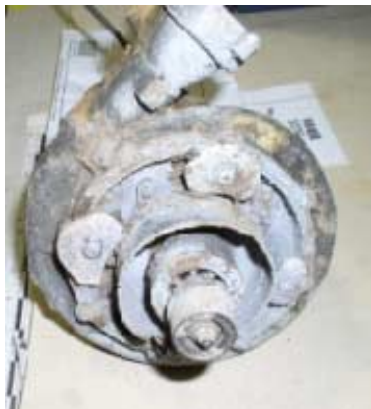
*Item 53764*

In the forward section, the stainless steel cold plates from the water cooling loops, both humidity separators (53764), the avionics bay heat exchangers, the cooling air ducts and miscellaneous water cooling lines were identified. The humidity separators survived with the foam insulation intact, which helped in differentiating them from the SpaceHab humidity separators, which do not have the same foam insulation. Twenty percent of the ECL items had sections of part numbers remaining, but drawing dimensions and/or bolt patterns were used to identify most items. All three fire bottle Halon containers were identified.

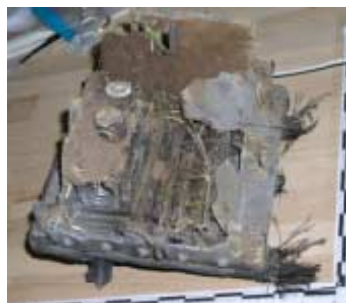
*Item 6800*

In the midbody, items recovered include Freon cooling loop hardware, aluminum cold plates (6800), accumulator parts (2029), and some cooling lines. The Orbiter has five gaseous nitrogen (GN2) tanks, all of which were recovered and identified. Most of the stainless steel vacuum vent and radiator Freon cooling lines were identified.

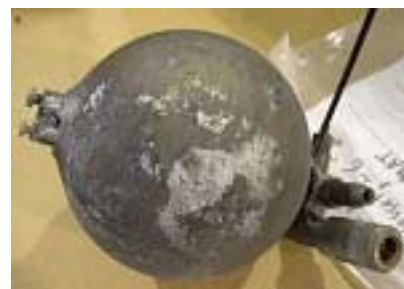
Item 59623

**Auxiliary power unit (APU)** – The APU propellant/GN2 tanks from systems 1, 2, and 3 (59623) were recovered. The tanks have moderate damage and all of the diaphragms are torn or detached from

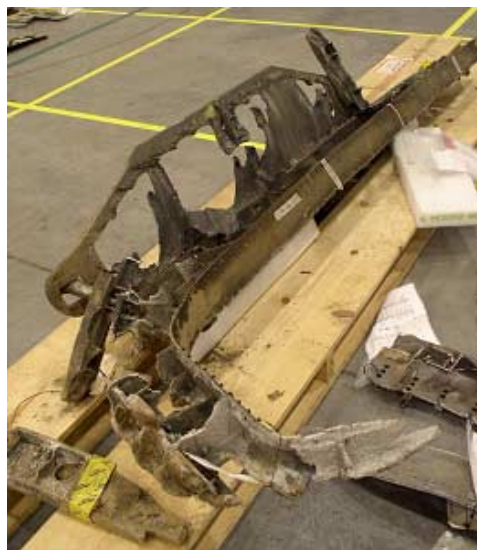
Item 266

**Major components** - Nine of the ten titanium longeron bridges (266) have been recovered and identified. Damage ranges from mechanical overload fractures, melted holes penetrating thinner flange areas, mounting hole galling, slag, and thermal damage. No damage trends are evident based on the location of this hardware in Orbiter. Eleven of the fourteen sill latches have been recovered, and have heavy damage similar to the longeron bridges. Two of the missing sill latches are secondary latches, and the third missing sill latch is part of the missing longeron bridge. All four of the keel bridges have been recovered, but only three of the keel latches were returned. The missing keel latch is torn off of the bay 3 keel latch.

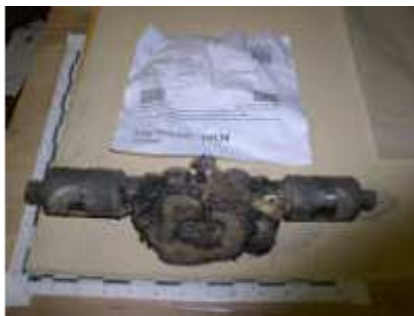
Item 16130

**PRSD System** - A hydrogen (H<sub>2</sub>) T-0 valve and a fuel cell 1 (FC1) reactant valve (16130) were identified, both of which came from H<sub>2</sub> manifold 2. The left hand fuel cell oxygen (O<sub>2</sub>) purge port was identified. Power reactant supply and distribution (PRSD) hydrogen relief 2 port was identified. The PRSD servicing panel (74847) behind door 45 was recovered. A few sections of PRSD plumbing remnants were identified through part marking or unique line insulation. Four Belleville washers, from two O<sub>2</sub> tank relief valves, were identified and have minor damage (internal to the relief valve).

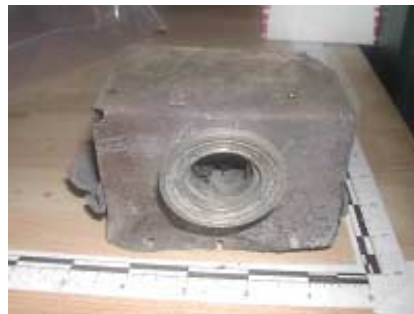
Item 10257

Several tank quantity probes and heater assemblies were identified. Several tank vacuum-ion pump converters (10257) were recovered, and some of them have thermal damage. The outer metal shell is removed from some of the recovered vacuum-ion pump converters exposing the internal components. One vacuum-ion pump (69490) was recovered with an intact magnet and exposed internal portion of the cathode.

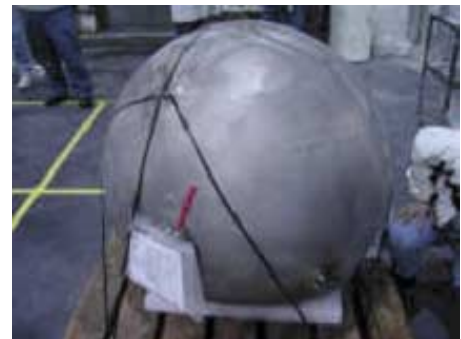
Item 1122

- O<sub>2</sub> tank 1, (1575)
- O<sub>2</sub> tank 2, (41040)
- O<sub>2</sub> tank 3, (36989)
- O<sub>2</sub> tank 4
- O<sub>2</sub> tank 5, (2087)
- O<sub>2</sub> tank 6 (EDO), (67814)
- O<sub>2</sub> tank 7 (EDO), (1122)
- O<sub>2</sub> tank 8 (EDO), (43558)
- O<sub>2</sub> tank 9 (EDO), (24316)
- H<sub>2</sub> tank 2, (1194)

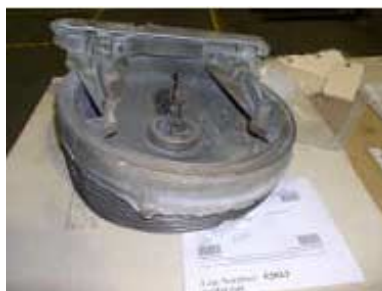
Item 52023

- Portions of the potable water tanks (52023) and the waste tank (12055) were recovered. Some tank outer skin sections were also recovered. The internal bellows were separated from the outer vessel container. One supply water valve was found but was not identified to an exact location. The waste dump nozzle (8118) was recovered with part of the skin panel.

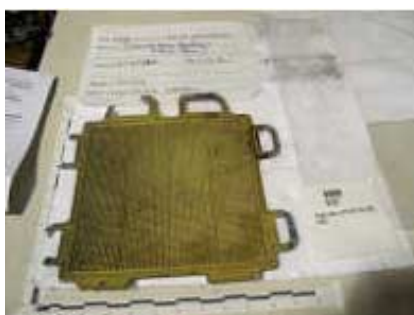
Item 8767

**Fuel Cells** - Fuel cell (FC) components were recovered with varying thermal damage. Approximately twenty of 288 internal cell reactant plates (8767) were identified and traced to their original FC. Several plates are nearly intact. Hundreds of small pieces of cell plates were also recovered but could not be identified.

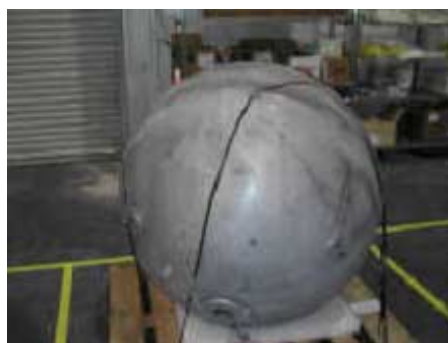
Item 214

- H2 tank 3, (9279)
- H2 tank 5, (217)
- H2 tank 6 (EDO), (206)
- H2 tank 7 (EDO), (219)
- H2 tank 8 (EDO), (214)
- H2 tank 9 (EDO), (209)

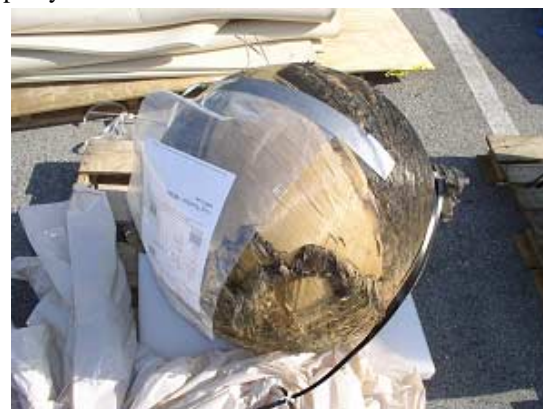
Item 49386

**MPS components** - The helium supply tanks (49386), which are made from two, forged hemispheres of titanium 6AL-4V alloy and covered with epoxy-impregnated Kevlar-49 fiber strands remained fully intact. The three 17.3 cubic feet and seven 4.7 cubic feet helium supply tanks were recovered and

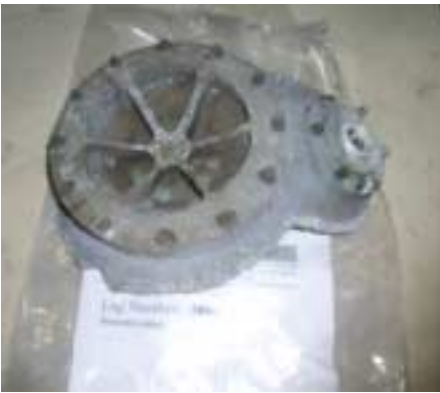
Item 56643

are charred and unraveled. No MPS valves, neither mono-stable nor bi-stable were recovered intact. All four of the fill and drain valve actuators, less the gear racks, were recovered, with the two LO2 valve (16931) visor blades still being attached to the actuators. Prevalve (56643) pieces were limited to housing flanges, anti-slam mechanisms, detent rollers/covers/belleville washers, visor/shaft assemblies, and actuator clutch/bearing assemblies. Mono-stable valve actuator internals such as pinion gears and gear racks along with housing flanges were recovered.

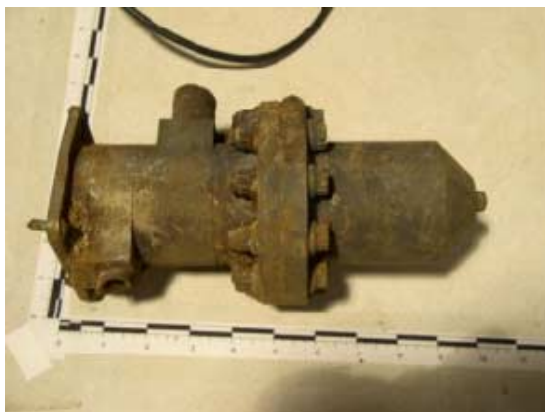
Item 7010

- Partial vibration isolators
- Recirculation pump cover plates, rotor, stator, and inducer
- GH2 filter assembly and element (7010)
- LO2 engine cut-off sensor MT2
- LH2 flame arrestor
- 1-inch relief valve SOV bellows/poppet assembly
- Curtain attach plate segments and retainer brackets

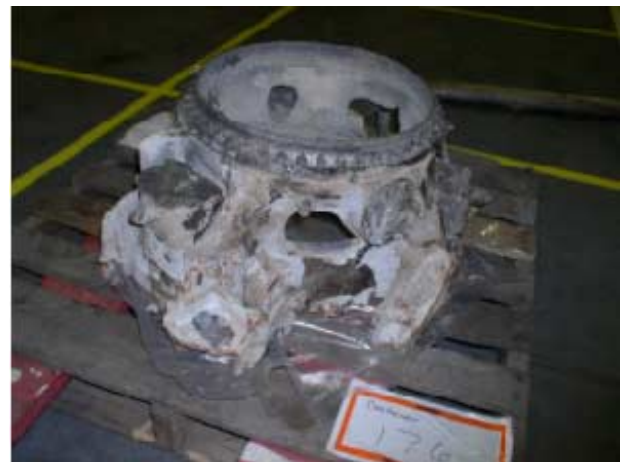
Item 22229

The Orbiter-to-external tank 17-inch disconnect housings (22229) were both recovered, but the associated ancillary tubing, drive arms, flapper valves, and latches are either missing or in various stages of thermal degradation. LH2 4-inch recirculation return system and gaseous oxygen/ gaseous hydrogen (GO2/GH2) 2-inch pressurization disconnect primary and secondary belleville springs

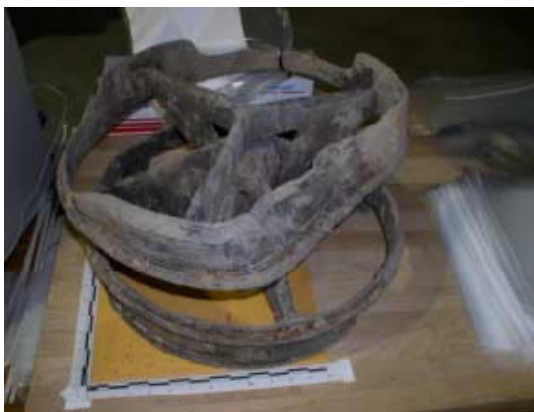
*Item 1540*

**MPS Pressure Carriers** - Less than 5% of the MPS system lines/tubing was/ were recovered. None of the propellant system vacuum jacketed lines were recovered intact. Small segments of Inconel internal pressure carrier lines and multiple pieces of bellows convolutes (75590) were recovered along with the more robust line flanges, ball strut tie rod assembly (BSTRA) joints and gimbal/ gimbar joints. Four LH2 12-inch engine feedline, two LO2 12-inch engine feedline, and two LO2 17-inch BSTRA (1540) joints were recovered.

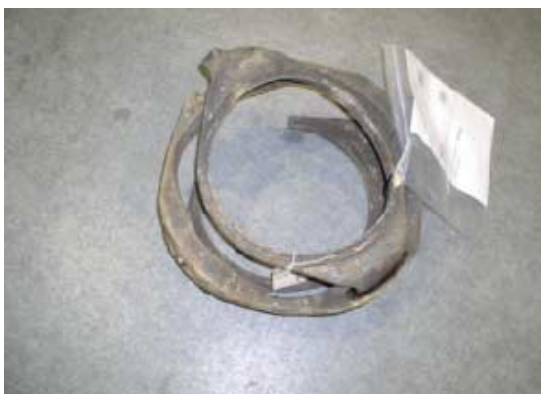
*Item 19520*

In addition, three 12-inch feedline gimbal rings (19520) were located and identified. Some of the vacuum jacketed line structural annulus stiffeners, standoff rings, burst disc assemblies, test ports and spacers were also recovered. The small, uninsulated tubing was generally charred beyond recognition and could not, in most cases, be specifically linked to a certain system. A small percentage of MPS pneumatic and GO2/GH2 pressurization tubing was identified by specific fittings, bend configuration, brazes and/or welds.

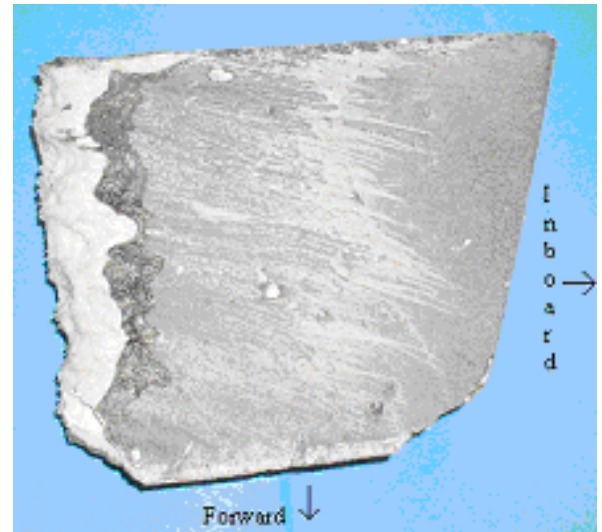
The LH main landing gear door tile on the forward outboard corner (identified as item 33590, P/N V070-191101-031) demonstrated a similar flow pattern as the left midbody panel (Item 283). Visual evaluation of the OML of the tile revealed apparent thermal flow erosion (melting, flowing and lifting of the RCG coating) of the outboard edge (directly adjacent to the outboard thermal barrier), with the flow direction inboard and slightly forward (Figure 9.1). This flow pattern was oriented approximately ninety degrees from the nominal flow direction expected in this area. In addition, the IML showed similar evidence of thermal flow erosion, but indicated the flow direction to be from inside the forward outboard corner of the main landing gear cavity, outward and forward. X-ray radiography did not detect any notable features aside from the

Figure 9.1. Left landing gear door perimeter tile, forward corner, item 33590

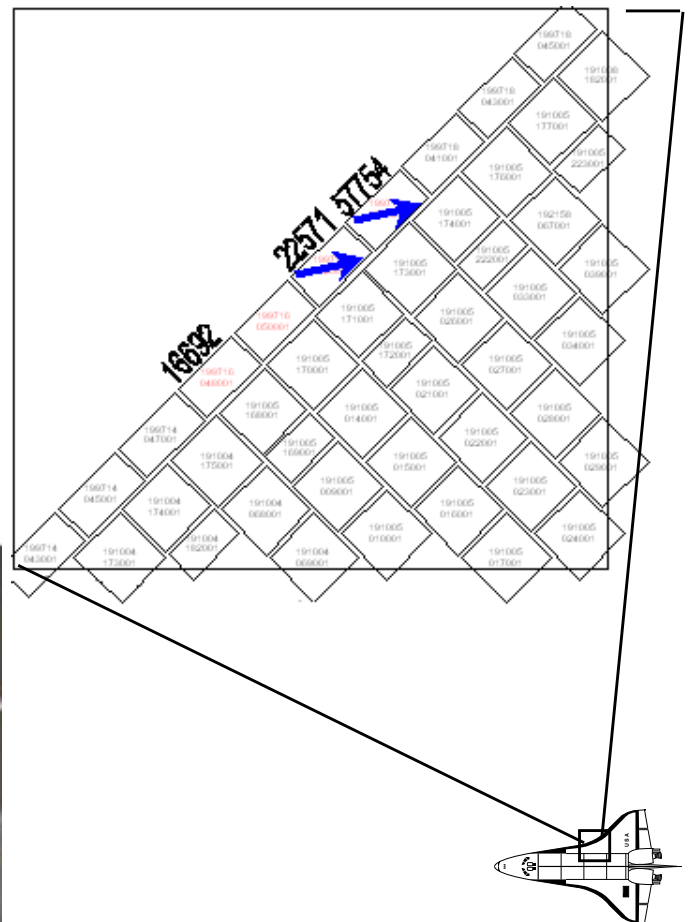
Evidence of overheating and slumping was observed on three LI-2200 Lower Left Carrier Panel 9 tiles adjacent to left hand RCC panel 9. The item numbers of tiles are: 16692 (V070-199716-048), 22571 (V070-199716-052) and 57754 (V070-199716-054). Figure 9.2 shows the simulated configuration of the carrier panel tiles. Depressed/slumped and eroded regions were observed in two of the three tiles (Items 16692, 22571). For

Figure 9.2. Reconstruction of recovered left hand lower LESS Carrier Panel 9 tiles.

example, the forward-facing sidewalls of Items 16692 and 22571 that nominally seal against the lower RCC panel 9 heel were severely slumped and eroded.

One internal LI-900 tile originally located on Lower Left LESS Carrier Panel 9 was recovered. This tile (Item 50338, V070-194205-004) exhibited a heavily slumped and cratered appearance (Figure 9.2). An additional internal LI-900 tile was recovered from upper Left LESS Carrier Panel 8. This tile exhibited a greenish coloration and heavy slumping (Figure 9.5). The surface deposits on internal tiles 50336 and 50338 were not as thick as those

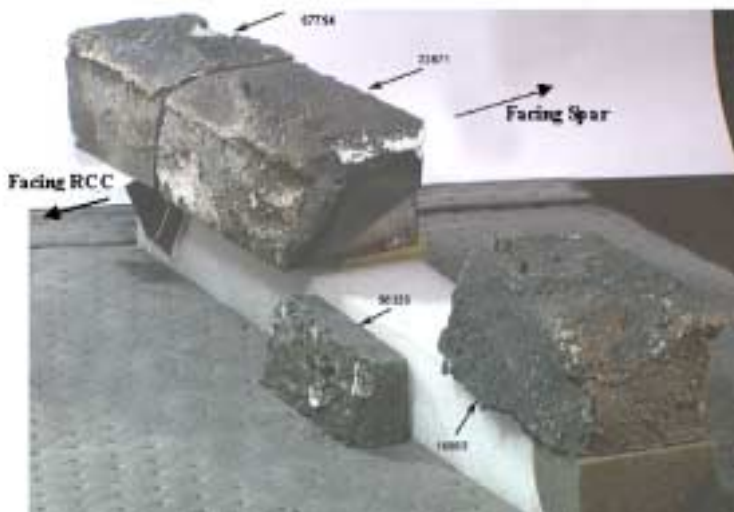
Figure 9.3. Top view of reconstruction lower left LESS Carrier Panel 9.

Dark-colored deposits were observed on all three outer mold line (OML) tiles (Items 16692, 22571, 57754). The thickness of the deposits varied across the tile surfaces. In the case of 22571 and 57754, the deposits produced visually apparent flow-like patterns oriented in the aft/outboard direction (Figures 9.3 and 9.4). Visual evaluation showed evidence that in some locations on the tile sidewalls, the deposits had built up over adjacent soft goods. This was supported by the presence of entrapped ceramic fibers in the deposits.

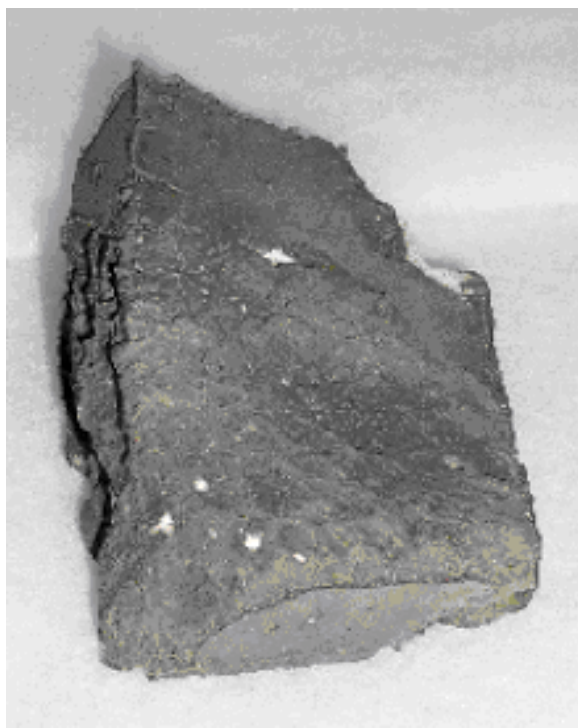
Figure 9.5. Upper left hand LESS Carrier Panel 8 internal tile (Item 50336)

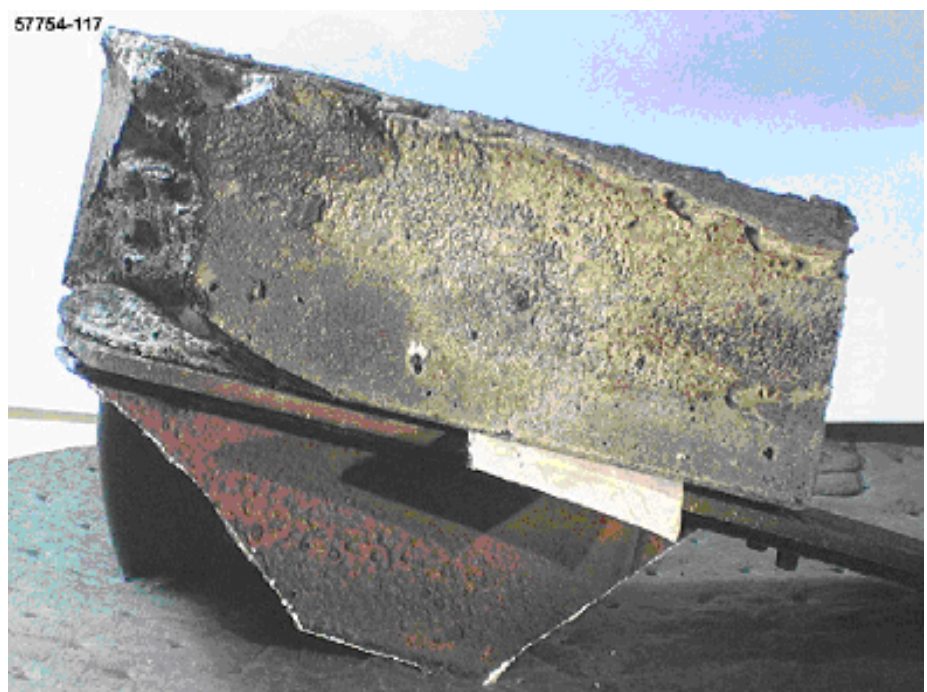
Tile item 57754 remained bonded to a section of underlying carrier panel 9 (Figure 9.7). Tile items 22571, 16692, 50338

Figure 9.7. Tile Item 57754 bonded to section of carrier panel

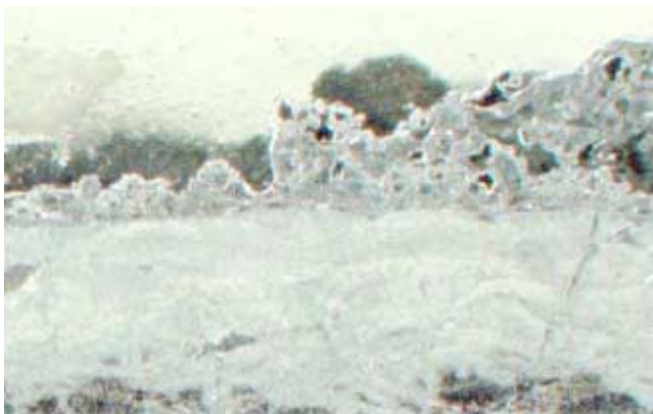
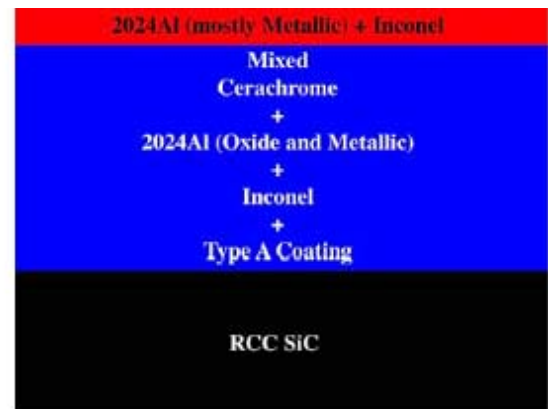
1. Aluminum was detected in all layers of the deposits on the RCC Panels (Figure 9.10)

Figure 9.10. Cross-section of LH Panel 4 Lower Inboard (Item 80632)

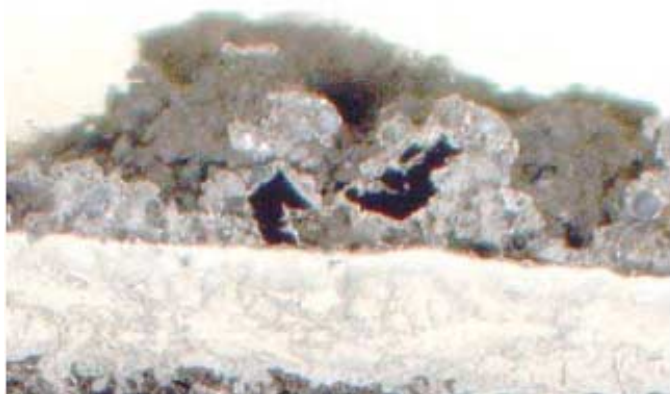
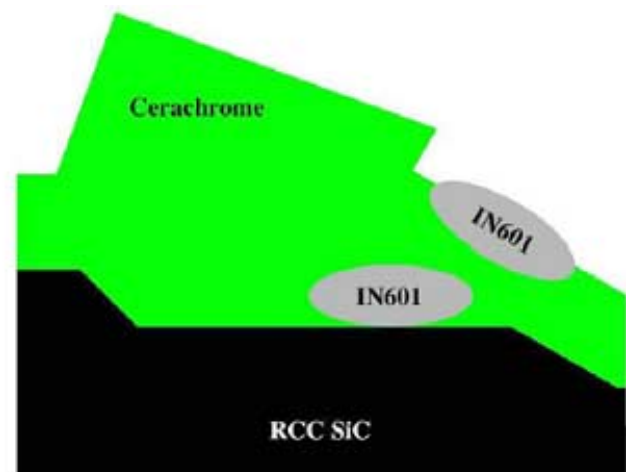
2. Aluminum was not detected in the first deposited layer on the RCC Rib (Figure 9.11). This is unlike the observations of LHRCC panel 8 and is similar to LHRCC panels 5 & 7.

Figure 9.11. Cross-section of RCC Panel 4 Lower Inboard Rib (Item 80632)

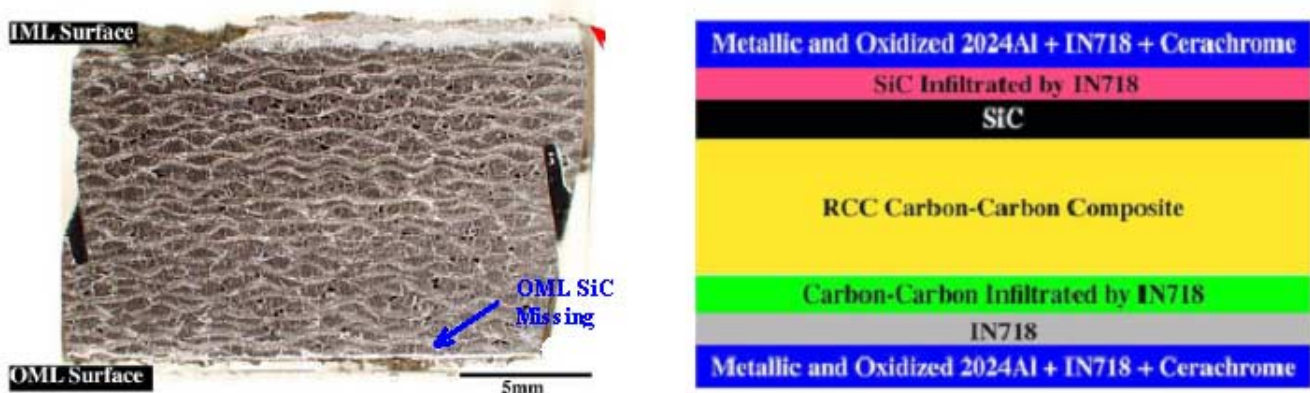
Figure 9.15. Cross section of Panel 8 Outboard Rib (Item 24724)

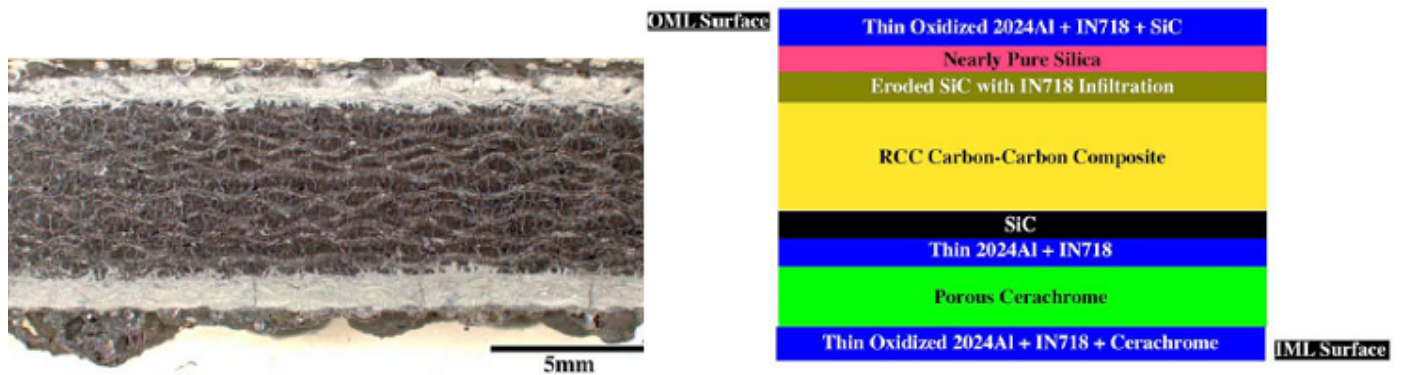
Figure 9.16. Cross section of Panel 9 Upper Rib (Item 7025)

- Erosion only detected on the OML of Item 7025 (Panel 9 Inboard Rib) (Figure 9.16)
- Smaller quantities of molten Cerachrome were detected in the deposits relative to LH RCC Panel 8

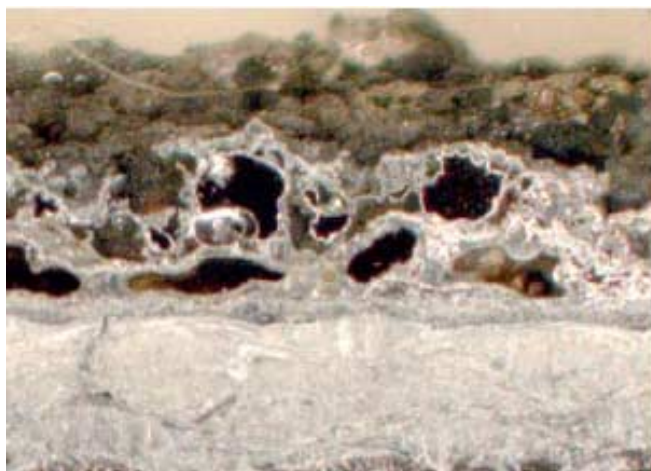
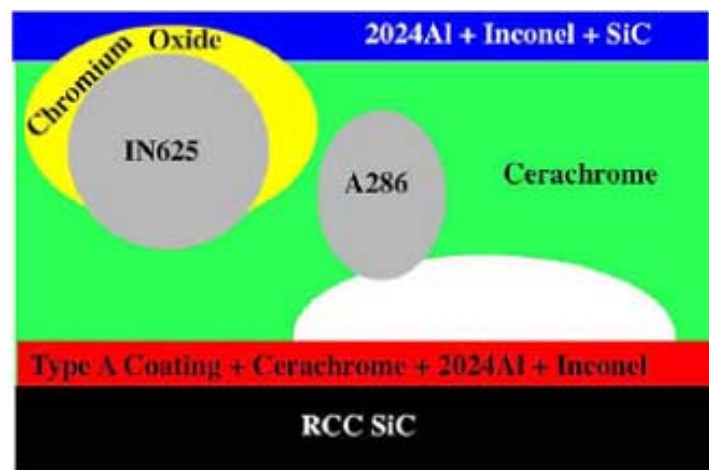
- Cerachrome was porous and contained less amounts of aluminum
  - Outer layers had less amounts of aluminum as a top layer
- Samples contained spheroids of A286, IN718, and IN625 alloys (Figures 9.17-9.18)

Figure 9.17. Cross section of Panel 9 Upper Outboard (Item 38223)

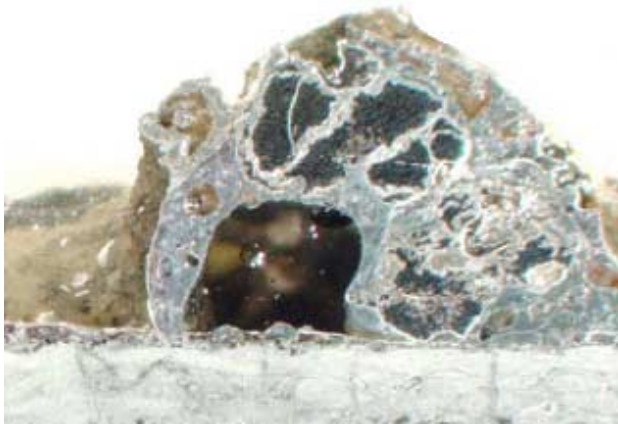
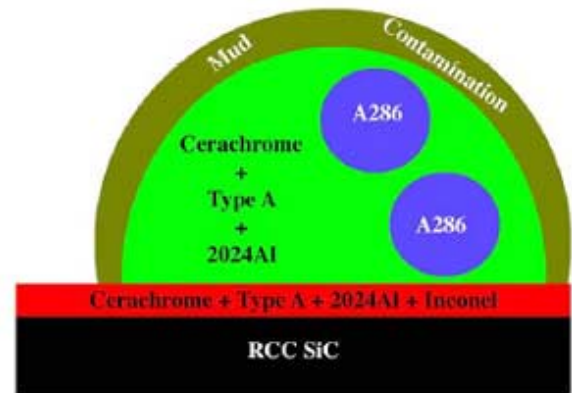
- A286 alloy was not detected in the first layers
- There were less deposits on the IML of the Outboard Rib (Item 29741) than that of the IML of RCC Panel 8 (Item 61143)

Figure 9.18. Cross section of Panel 9 Rib (Item 29741)

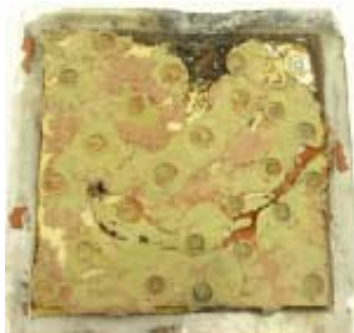
*Backside Heating*

**Backside Heating** - Separation of tile from structure that occurs at the primer interface due to internal vehicle heating. Item 57481 shown

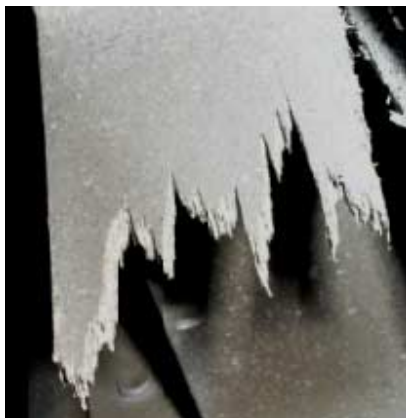
*Broomstraw*

**Broomstraw** - Type of aluminum alloy fracture due to a high temperature failure of the material where there is incipient melting along the grain boundaries. At high temperatures very little applied stress is needed to fracture the material. Item 105 shown.

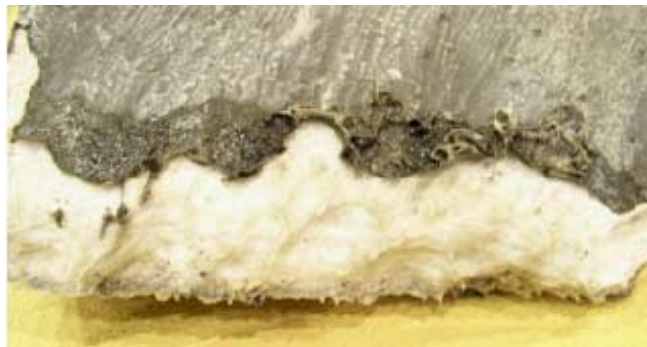
*Glassification*

**Glassification** - Melting of the base silica material of a tile forming glass when subjected to temperatures over 3000 degrees Fahrenheit. The RCG must be damaged or missing for this to occur.

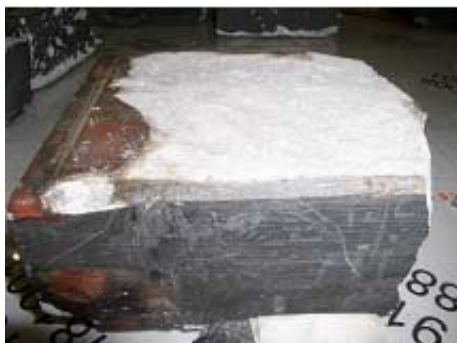
*In-Plane TPS Fracture*

**In-Plane TPS Fracture** - Tile fracture

occurring about 0.10 inches above the IML just above the densified portion of the tile. Also known as densification layer failure.
